# *Rail tie infrared scan identifies poor tie conditions*

# Examples of Rail Defects

# Sperry Car tests for internal rail defects and rail surface conditions

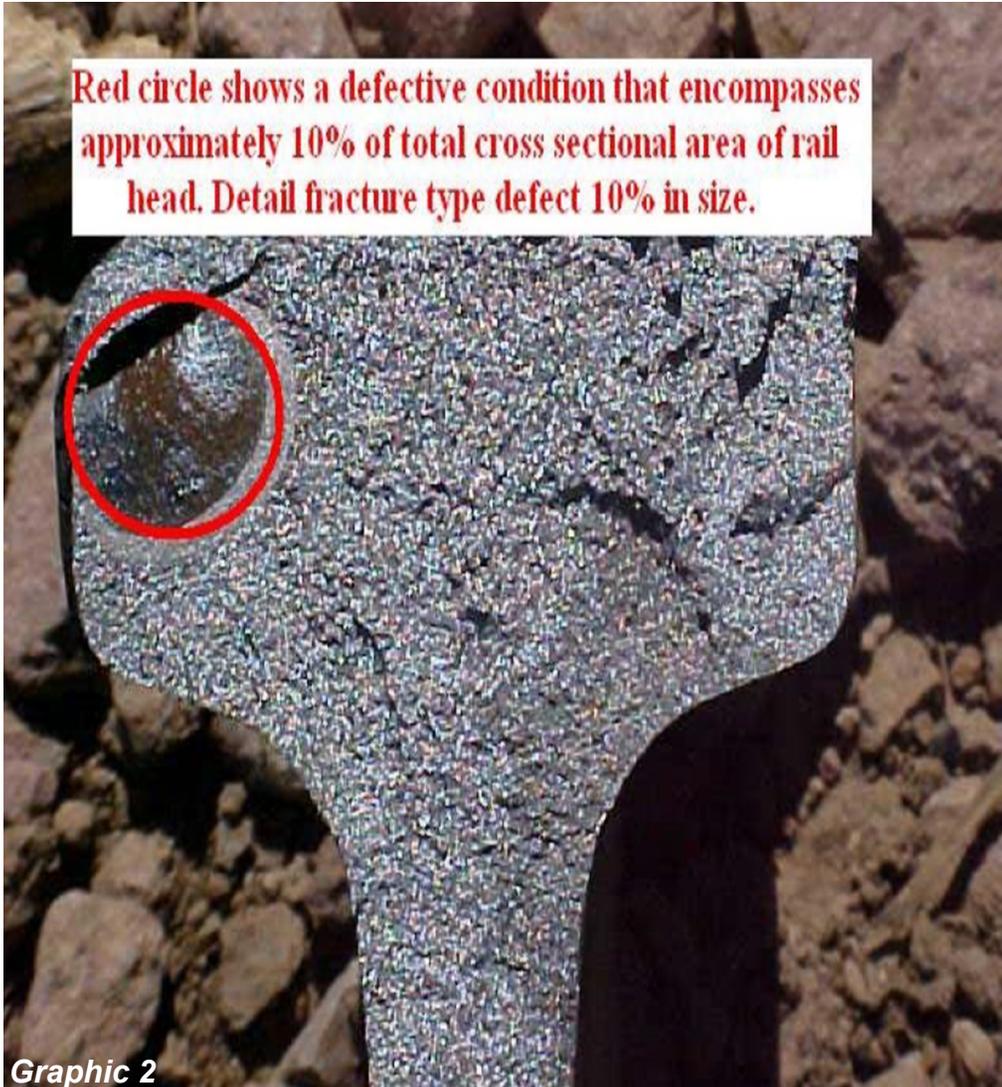
Graphic 2

Red circle shows a defective condition that encompasses approximately 10% of total cross sectional area of rail head. Detail fracture type defect 10% in size.

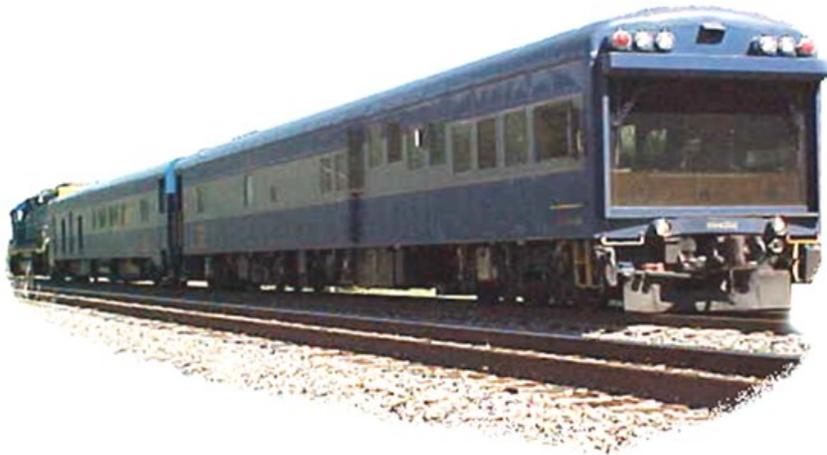
**TGC2**

*Geometry Vehicles test track structure, alignment and gauge*

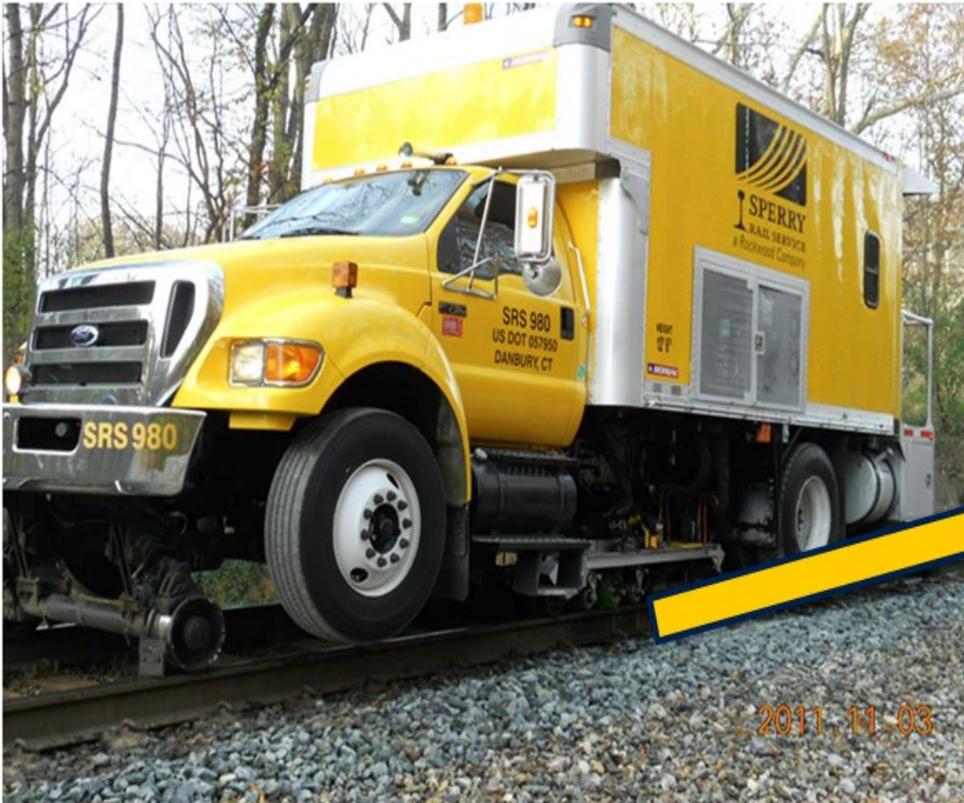
Graphic 4

Ultrasonic system

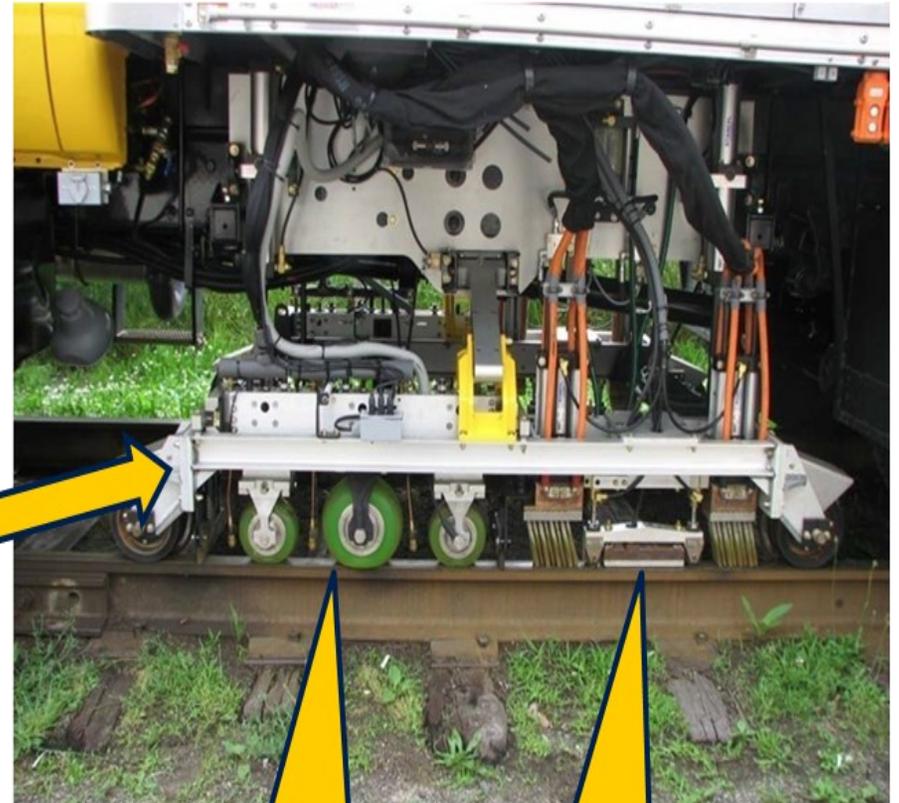
Electrical current system

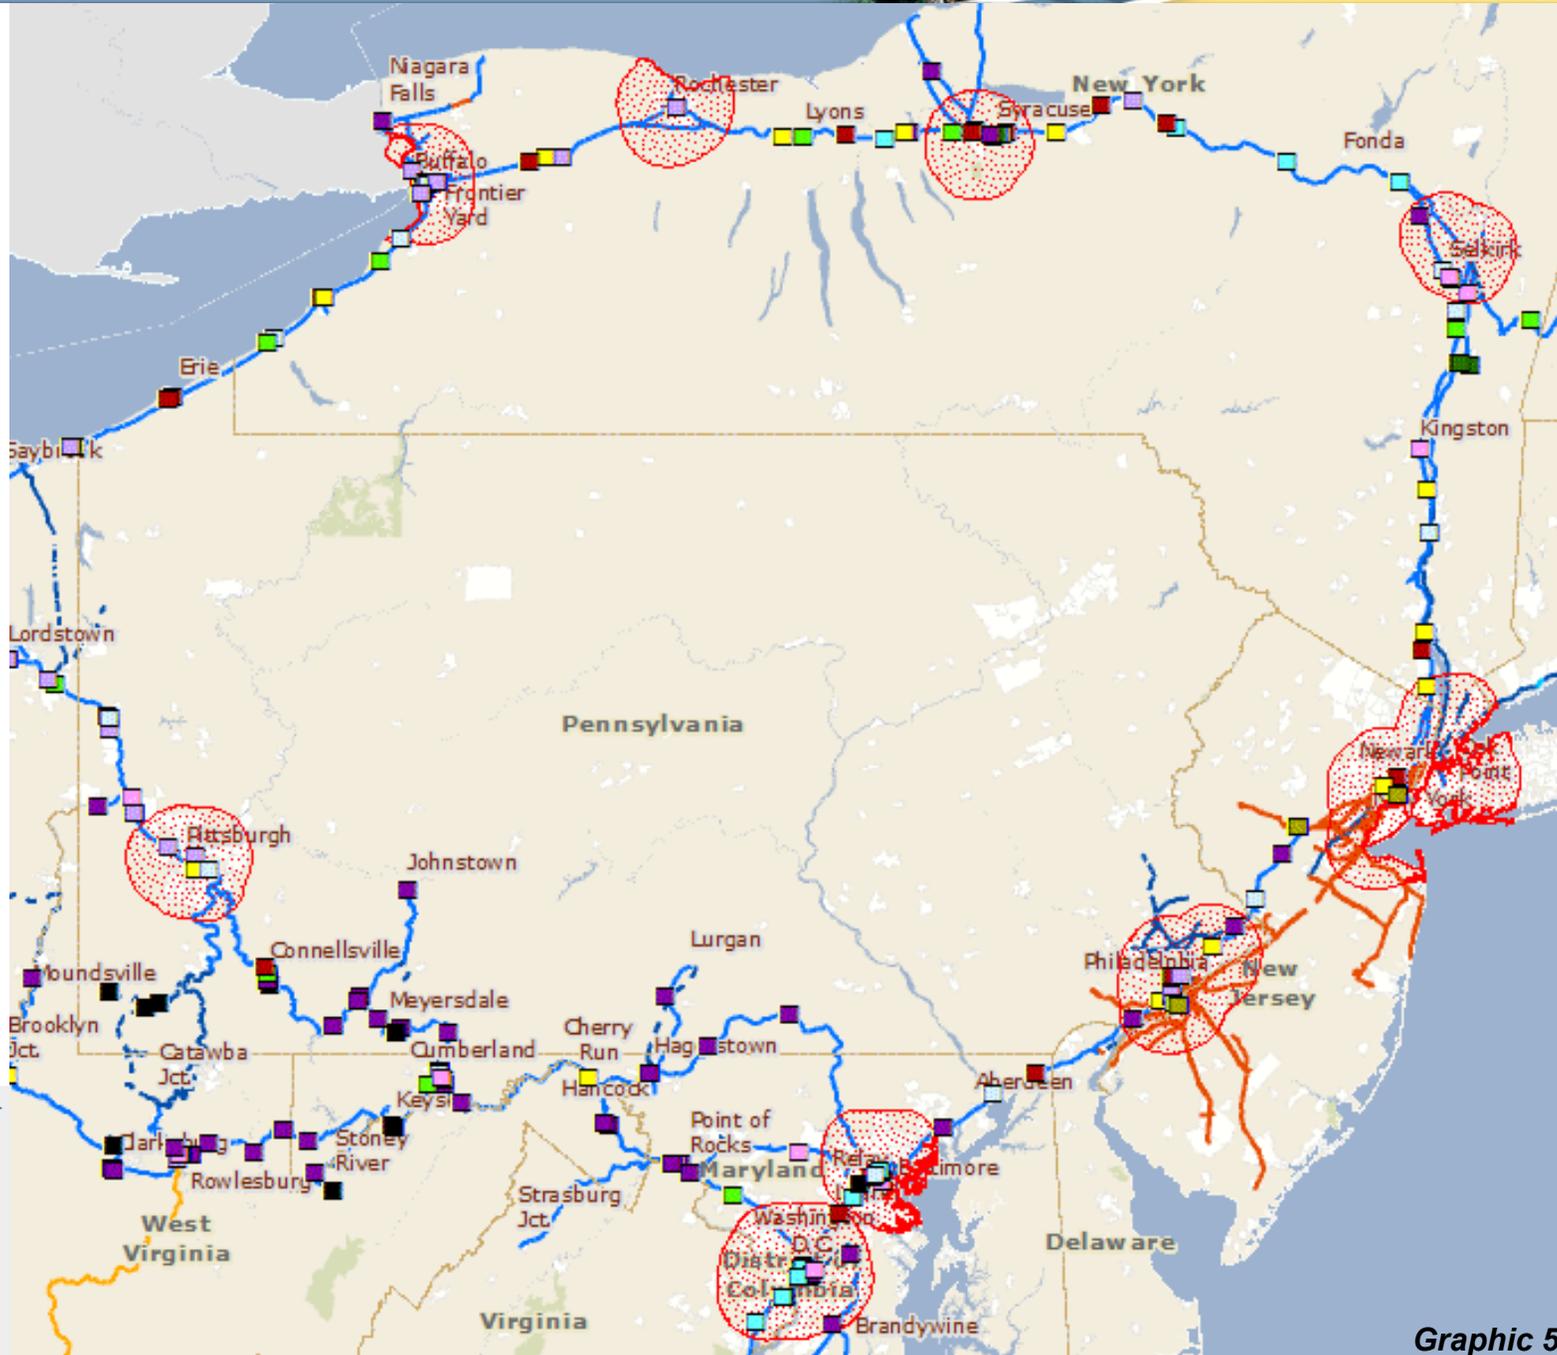
*Graphic 5*

*SecureNOW  
system as  
seen by  
PEMA*
